Manhole Inspection Summary

Manhole # S27K1_006MH

Insp Date: **3/12/08 8:55 AM**

Location Address: **2490 Giles Rd.**

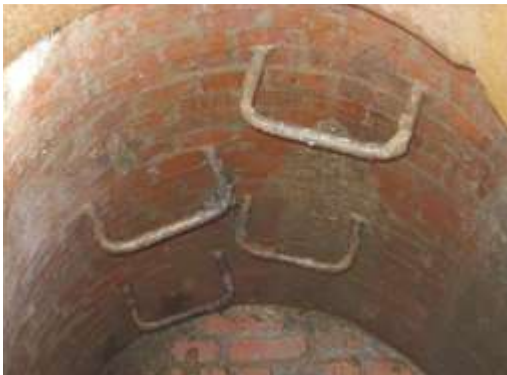
Steps Count: **4** Missing: **0** ☒ **Corroded**

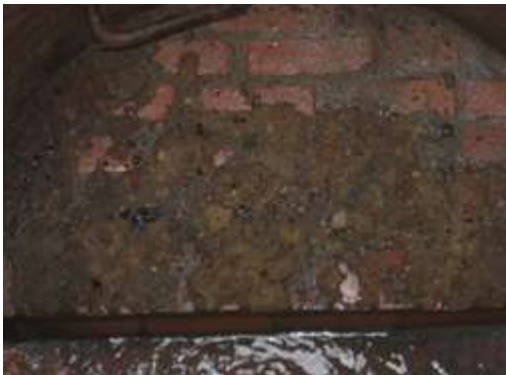
Defect 1

Bench

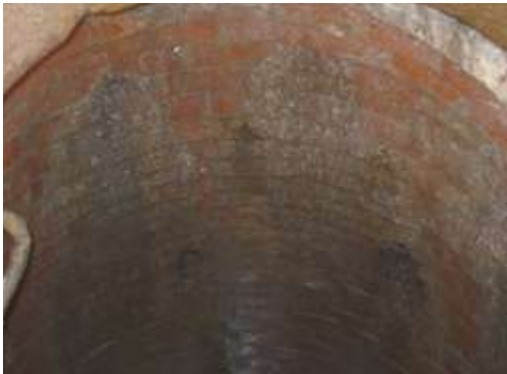
Defect 2

Infiltration: ☐ None ☐ Joint ☐ Cracks ☐ Mortar ☐ Roots ☒ **Wall**

Wall

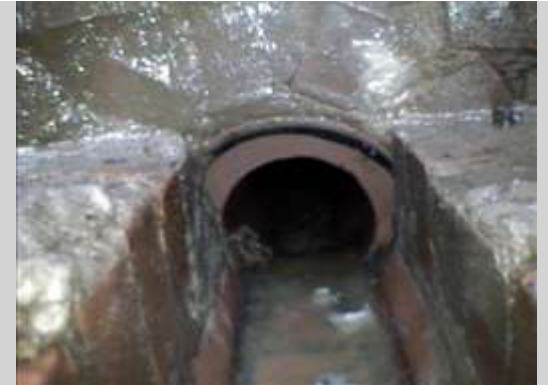
12 O'Clock Outflow

8 in. Circular Gravity Sewer
Pipe Out @ 12 O'Clock

Pipe Height: **6** (in.) Rod and Bar (Angled)
Pipe Material: **Clay** ☐ Pipe Lined
Invert Depth: **7.99** (ft.) Flow Characteristics: **Fast**
Deposits: ☒ None ☐ Mud ☐ Sludge ☐ Debris ☐ Grease
Silt Depth: (in.) Deposits Extent:
Infiltration: **None** Pipe Seal Cond: **Sound**

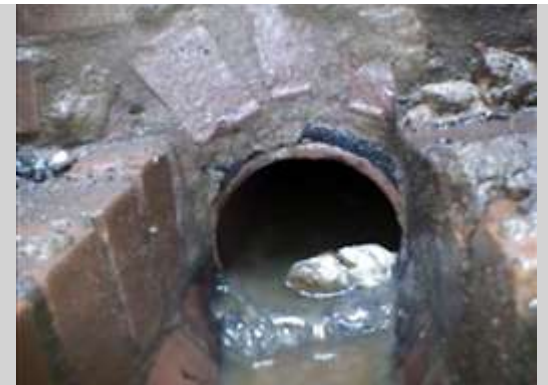
6 O'Clock Inflow

6 in. Circular Service Sewer
Pipe In @ 6 O'Clock

Pipe Height: **6** (in.) Rod and Bar (Angled)
Pipe Material: **Clay** ☐ Pipe Lined
Invert Depth: **7.96** (ft.) Flow Characteristics: **Fast**
Deposits: ☒ None ☐ Mud ☐ Sludge ☐ Debris ☐ Grease
Silt Depth: (in.) Deposits Extent:
Infiltration: **None** Pipe Seal Cond: **Sound**
